This spreadsheet performs screening level calculations to estimate the effect of peeling leaded paint on the average concentration of lead in yard soil
3762 Marion St.

Property ID: 506	Date: 8-17-05
Address: 3762 MARION STREET	Telephone #:
Owner:	CO Certification #: 12860
Inspector/Assessor:

LBP Assessment Results

Property ID # 506 / 3762 Marion Street

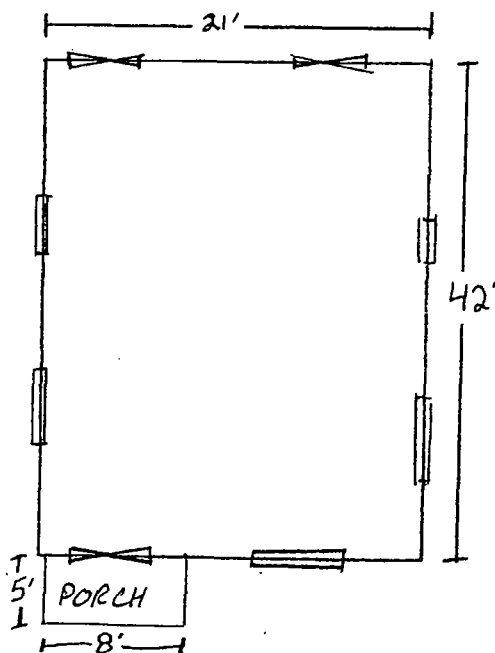
Plot Plan:

- GREEN WALLS
- TAN TRIM

Exterior Walls - TAN				Doors/Trim			
Material	Area	Peel/Chip	XRF (Lead)	Material	Area	Peel/Chip	XRF (Lead)
STUCCO	—	—	1.6	WOOD	42'²	PEEL	19.3
WOOD SIDING	—	—	7.7	BRICK	—	CRACK	12.5

Window Trim/Pascia/Soffit				Patios/Decks/Porches			
Material	Area	Peel/Chip	XRF (Lead)	Material	Area	Peel/Chip	XRF (Lead)
WOOD	4'²	PEEL	13.8	WOOD TRIM	18'²	PEEL	15.6
				WOOD COLUMN	24'²	PEEL	20.4
